Printronic Technical Bulletin	Number 5-0038	Revision A
	Product Type P5000	Date 03/01
Subject Dataproducts Shortline Interface – No Communications	Originator Gary Gentry	Page 1 of 1

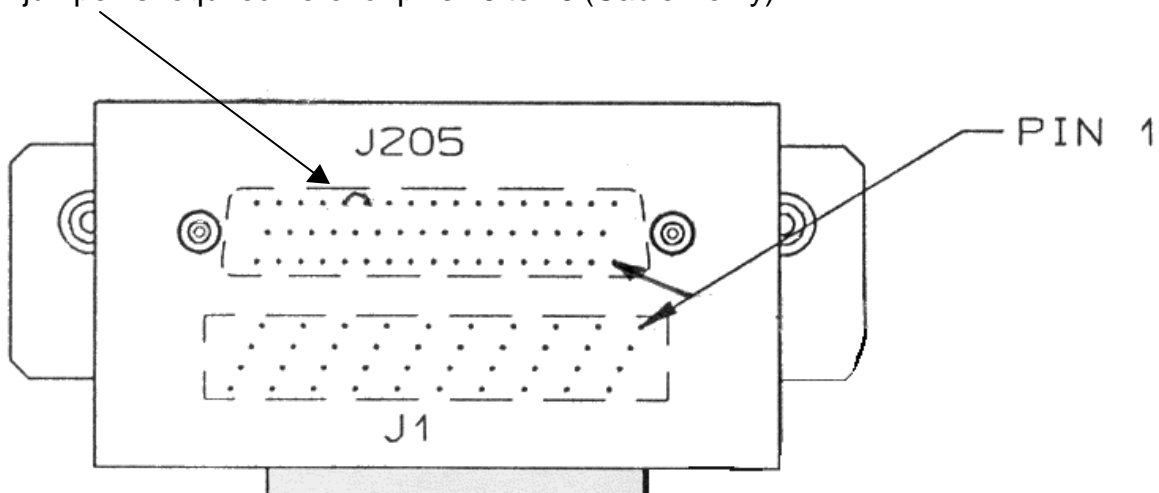
Printers shipped with part number 153364-001 – CN, DP I/O Cable Assy up to mid-February, 2001 or have had this cable installed as a field upgrade may experience no communications when using the Dataproducts parallel connector.

Below is the backside (solder-side) of PCBA 153385-001 with the Black Insulating Tape removed.

A jumper is required here for pins 45 to 46 (Cable Verify).

If the cable is found to be missing this jumper between pins 45 to 46 please contact the Customer Solutions Center at phone number 714-368-2686 to receive a replacement cable at no charge.
