Printronic Technical Bulletin	Number 7-0013	Revision B
	Product Type P7000	Date 06/11
Subject: To Improve the Pedestal Lid Closure	Originator MB Tan	Page 1 of 2

To improve the Pedestal Lid closure.

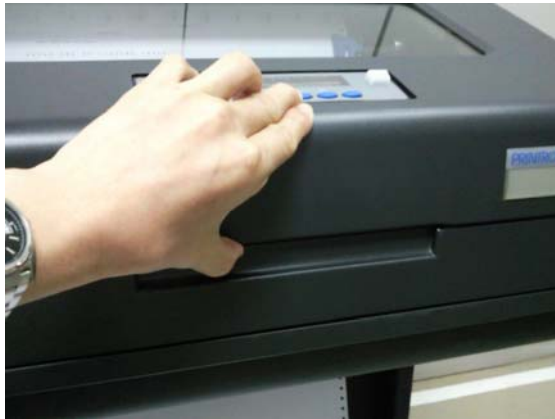
- 1) Open the printer cover (Lid assembly).

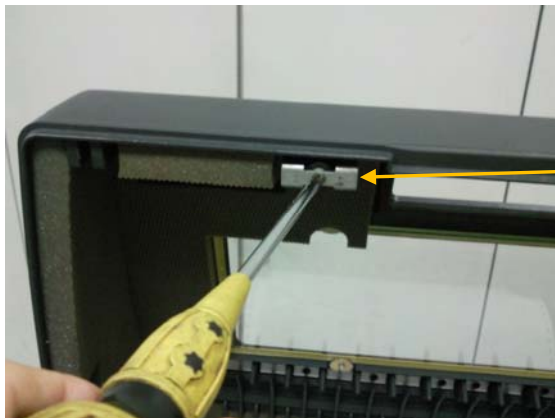
Strike plate

- 2) Unscrew and remove the Strike Plate from the Lid assembly.

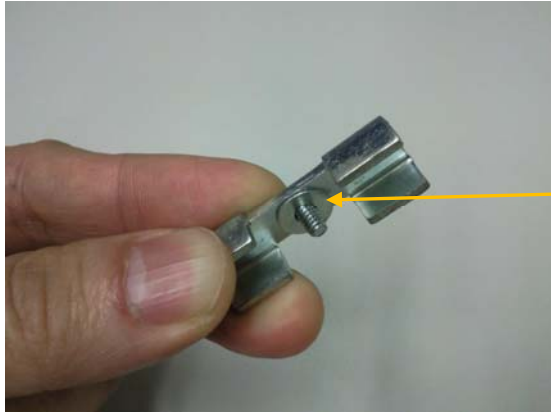
101526-002 Flat Washer

3) Install the Washer 101526-002 as shown.

4) Install the Strike Plate back to the Cabinet Lid assembly.

Note: This procedure is only applicable if the lid of printer cannot be closed fully, especially when it is new.

Note: Washer Part Number is: 101526-002.
This washer is flat, steel, zinc coated blue, 0.149" x 0.367" x 0.030".
